515 Somerville Avenue Somerville, Massachusetts

August 11, 2020

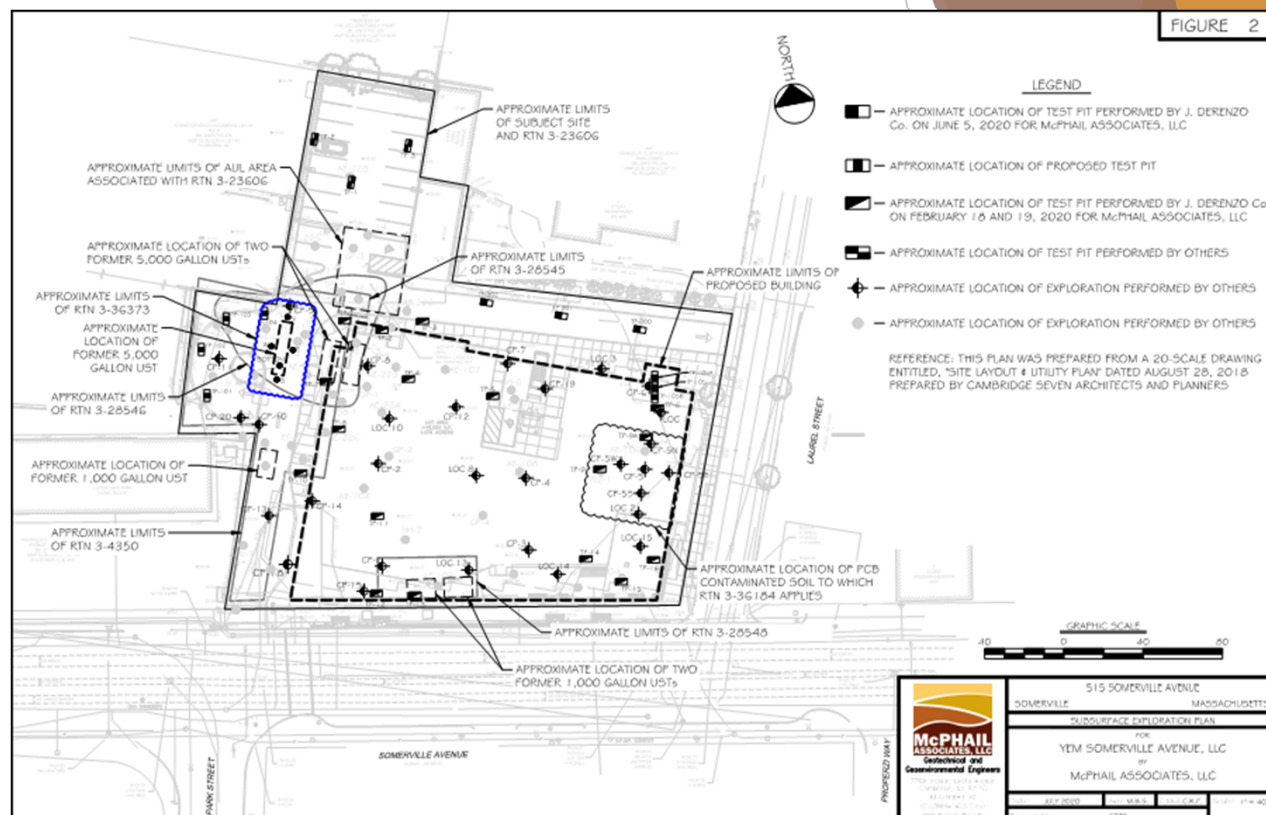
► Release Tracking Numbers (RTNs)

► 3-4350

► 3-23606

► 3-28545

► 3-28548

► 3-28564

Permanent
Solution
Achieved

► 3-36184

► 3-36373

Open

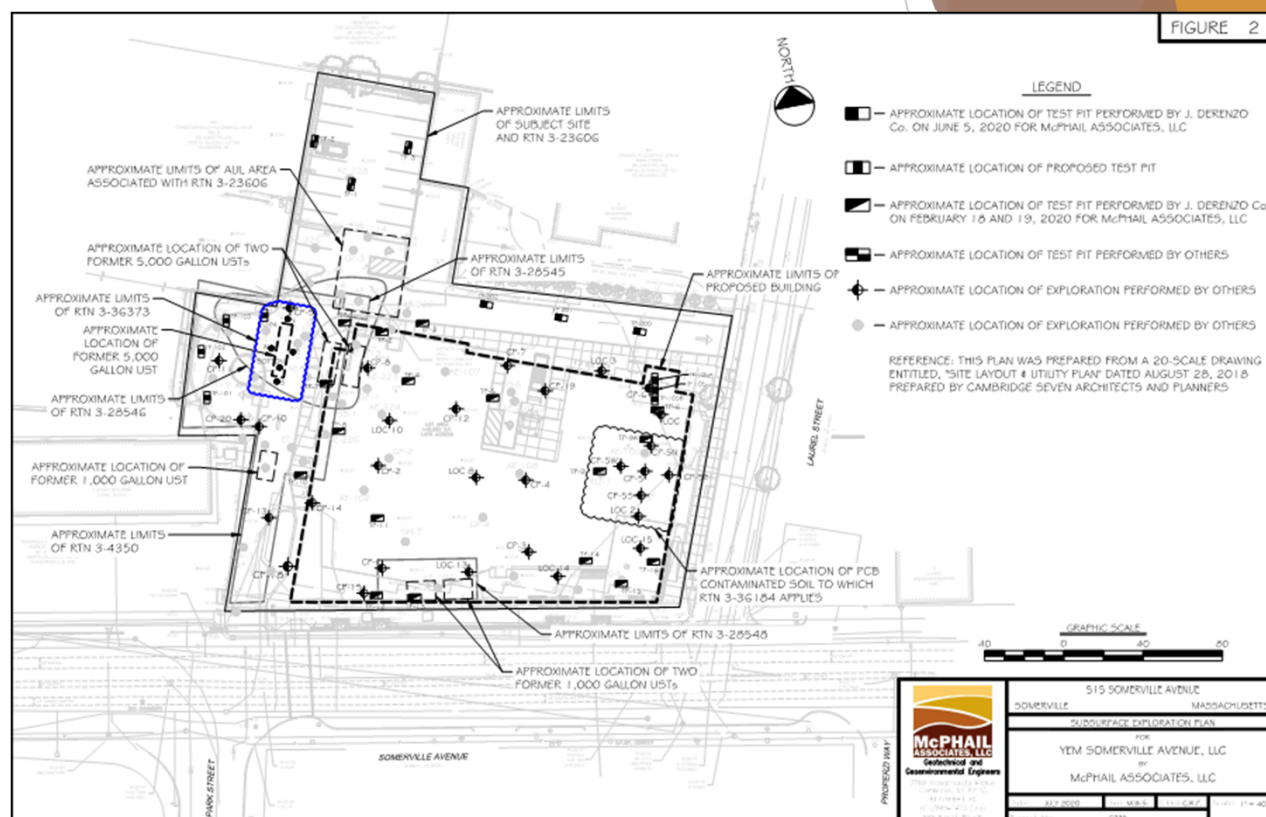
Constituents of Concern (COCs)

- ▶ 3-23606
 - ▶ Asbestos Containing Material (ACM)
 - ▶ Polycyclic Aromatic Hydrocarbons (PAHs)
 - ▶ Petroleum Hydrocarbons
 - ▶ Volatile Organic Compounds (VOCs)
 - ▶ Metals
- ▶ 3-36184
 - ▶ Polychlorinated Biphenyls (PCBs)
- ▶ 3-36373
 - ▶ Petroleum Hydrocarbons

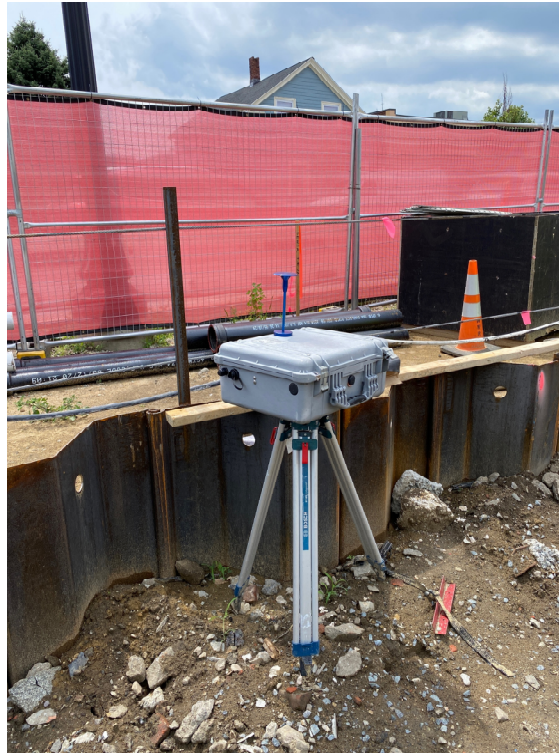
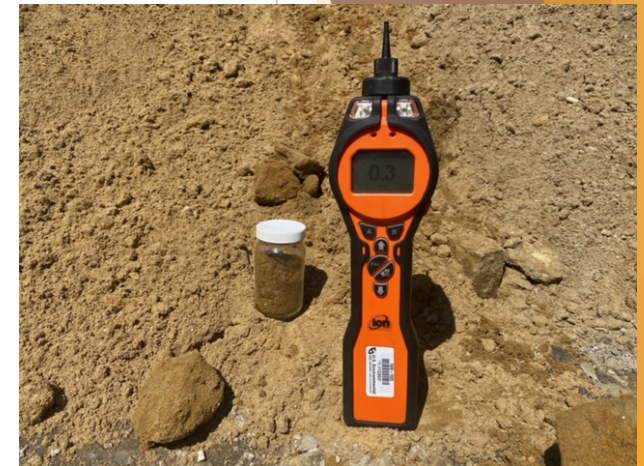
- ▶ Environmental Monitoring Plan
 - ▶ Dust Monitoring
 - ▶ Ambient Air Screening for VOCs

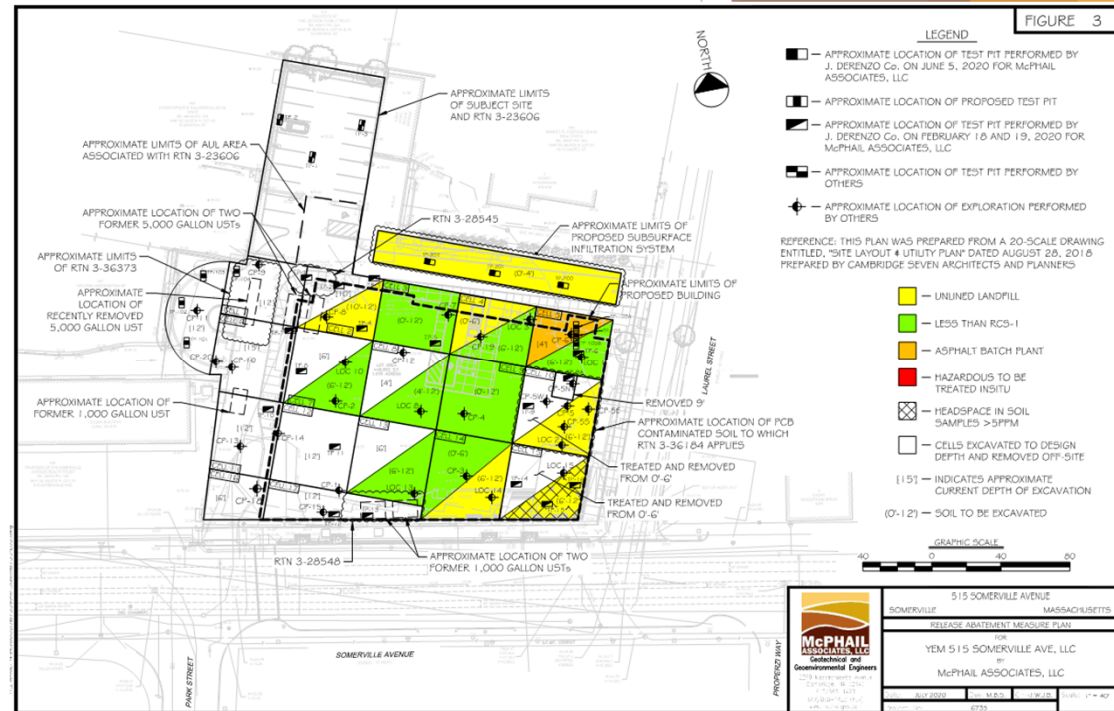
- ▶ Environmental Monitoring Plan
 - ▶ Dust Monitoring
 - ▶ Ambient Air Screening for VOCs
- ▶ RTN 3-23606
 - ▶ Upper 1.5' of clean soil cap material will be replaced with 1' of subbase material covered by 3.5" asphalt
- ▶ RTN 3-36184
 - ▶ PCB affected material excavated and removed off-site

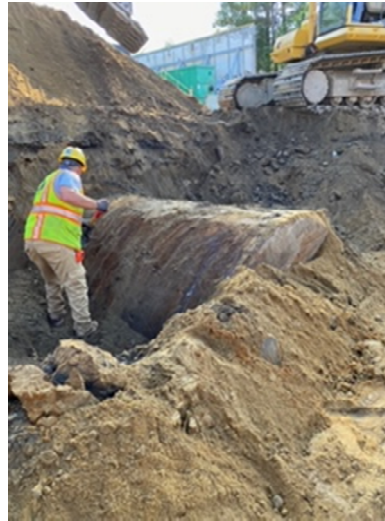
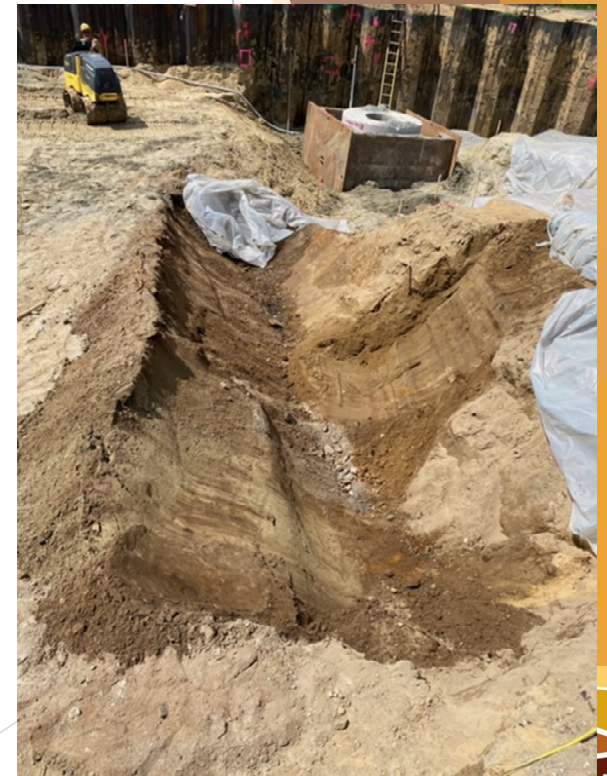
- ▶ Environmental Monitoring Plan
 - ▶ Dust Monitoring
 - ▶ Ambient Air Screening for VOCs
- ▶ RTN 3-23606
 - ▶ Upper 1.5' of clean soil cap material will be replaced with 1' of subbase material covered by 3.5" asphalt
- ▶ RTN 3-36184
 - ▶ PCB affected material excavated and removed off-site
- ▶ RTN 3-36373
 - ▶ Tank cleaned, emptied, and removed off-site
 - ▶ Affected material will be excavated and removed off-site
 - ▶ Further assessment activities to be performed
